Division of Oil Gas and Mining

Minerals Inspection Report

Mine Name: Point of the Mountain (South Hansen)	Permit Number: M035/0026	Mine Status: Active
Operator Name: Geneva Rock Products	Inspection Date: 07/19/2016	Permit Fees: Paid
Inspector(s): Leslie Heppler	Inspection Time: 9:00 AM	Bond Amount: \$970,927
Attendee(s): Scott Thayn, Project Manager	Weather: Warm and dry	Bond Escalation: 09/01/2014
Inspection Purpose: Routine inspection - Focused on county line		Prior Inspection: 05/01/2013

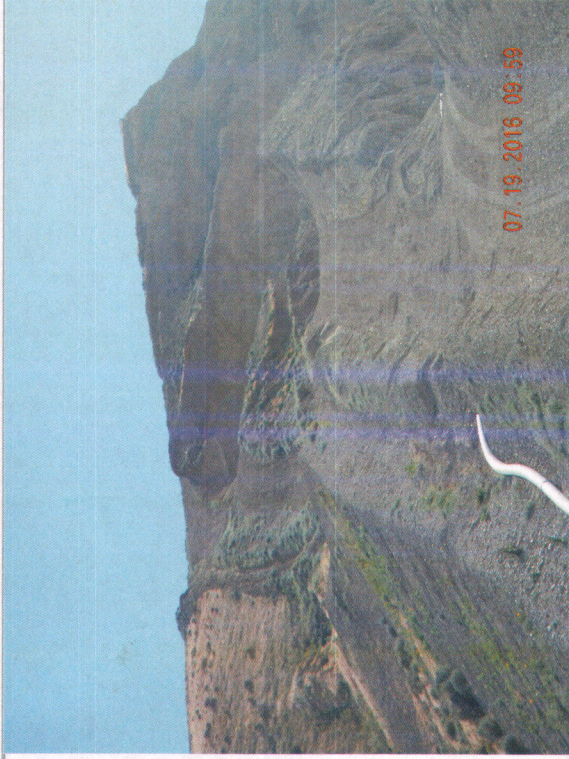
The focus of this inspection was area adjacent to the old radio tower and the county line. Discussed with Operator the difference between restoration and reclamation. In addition, discussed possible options on slope angles ranging from 1H:1V to 2H:1V for the area noted in the Division Directive dated December 23, 2015. The Division directive was written by Lynn Kunzler, edited by Paul Baker and signed by Mike Bradley.

Area to be restored/reclaimed

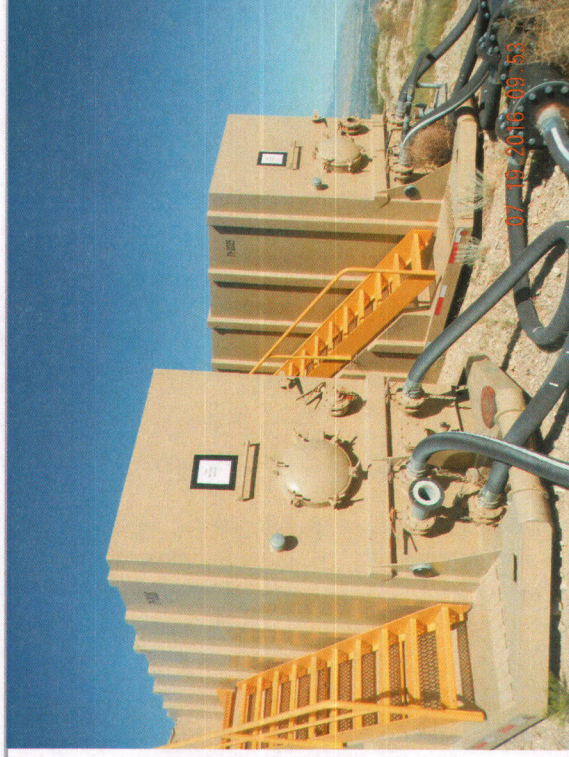
Two 20,000 water tanks used for dust suppression

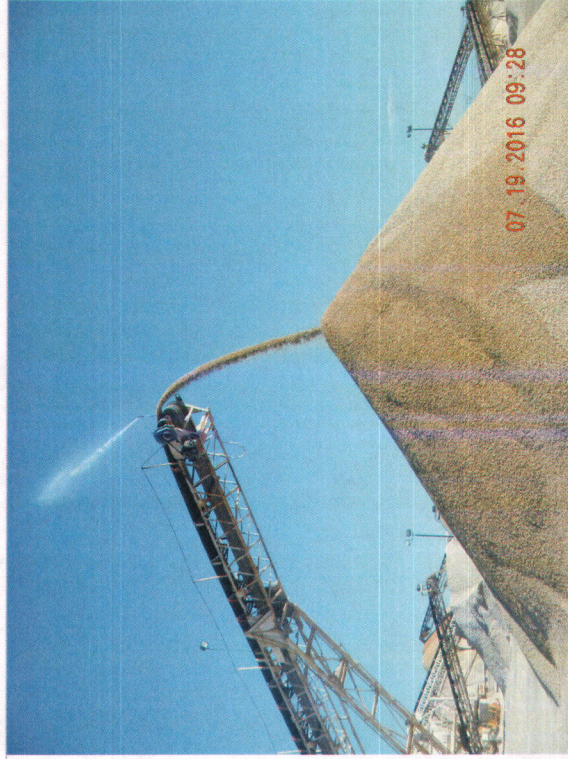
Dust suppression on stockpile

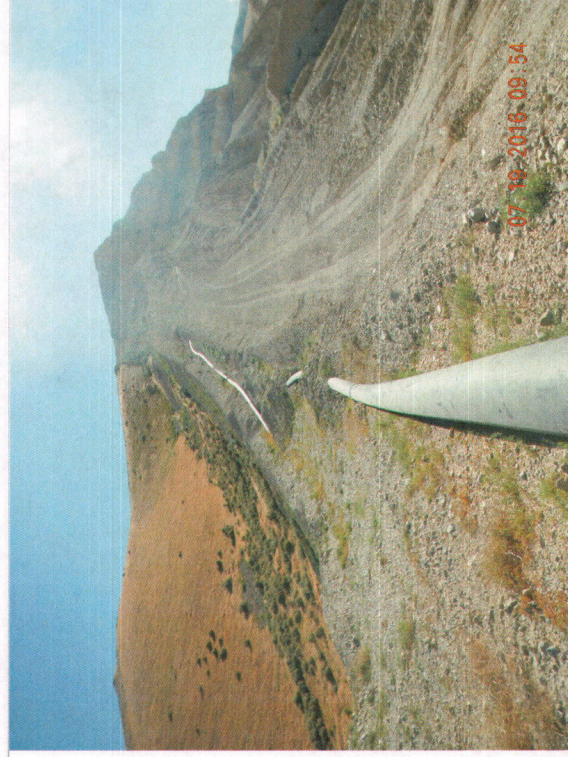
5. <i>Roads (maintenance, surfacing, dust control, safety)</i>	<input checked="" type="checkbox"/>	<input type="checkbox"/>
Roads were well maintained and water was used for dust suppression. In addition large diameter 8-12" water lines were installed for dust suppression of highwalls and stockpiles.

12" water line to the top of the hill
